~~RESTRICTED~~  
**UNCLASSIFIED**  
REPORT OF ACCIDENT TO  
AVRO AFGW 1 25201  
AT WILTON  
**UNCLASSIFIED**

REPORT ON ACCIDENT

AVRO ARROW I 25201

June 11, 1958

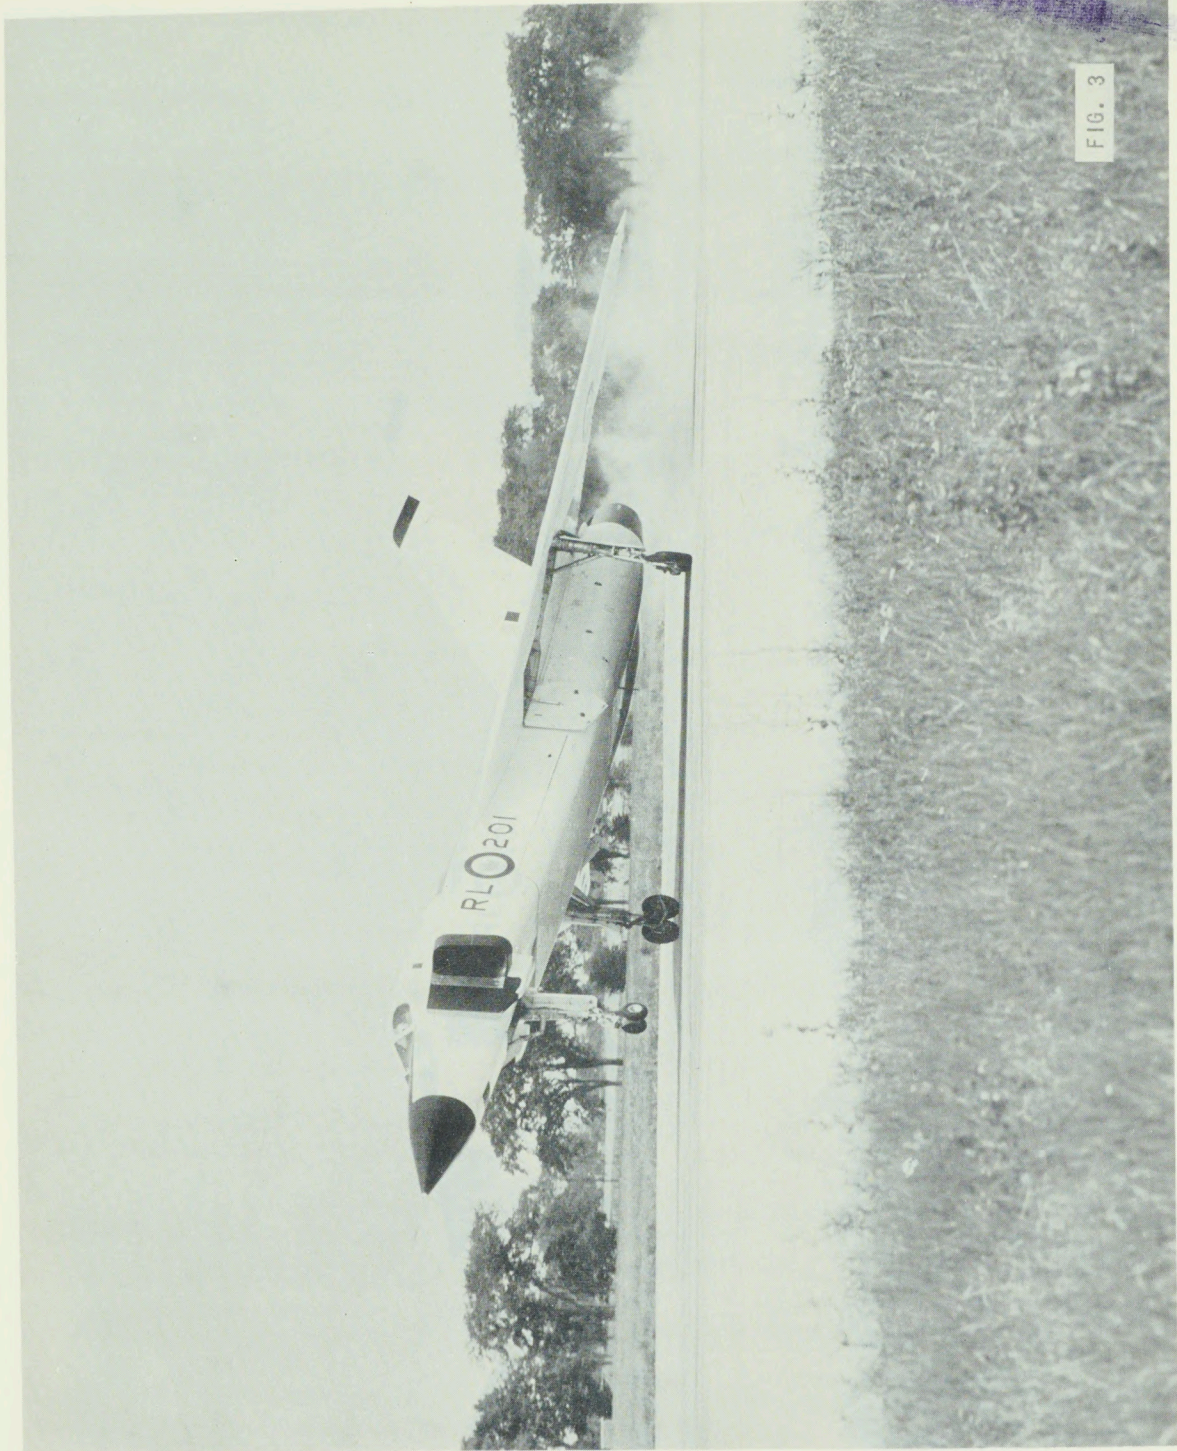
FIG. 3

Immediately after touch down (Fig. 3), the aircraft's weight caused the left-hand landing gear to turn further and assume the position which it would normally occupy when stowed in the landing gear bay (Ref. para. 3.3). The drag chute was then deployed. Figure 6 shows smoke coming from the left-hand tires, due to their misalignment with the aircraft's path. The aircraft continued to swing towards the left-hand side and corrective brake action had no effect in arresting the swing. The pilot then considered that the drag chute may be causing the swing and jettisoned the chute. Figure 7 shows the aircraft in various positions until it left the runway. When the left-hand wheel struck the soft ground, the aircraft swung violently to the left, causing the landing gear to collapse due to the excessive loads imposed on it. Figures 12 and 13 are aerial photographs taken shortly after the accident. The skid marks shown on Figure 14 are those made by the left-hand landing gear at the touchdown point, and indicates the increase in the spread of the tires, as the bogie is twisted further out of line, due to the increasing weight on the landing gear. Figure 15 indicates the point at which the left-hand tires burst. This occurred at approximately 3/5 of the total distance which the aircraft travelled (approximately 4,000 ft.).

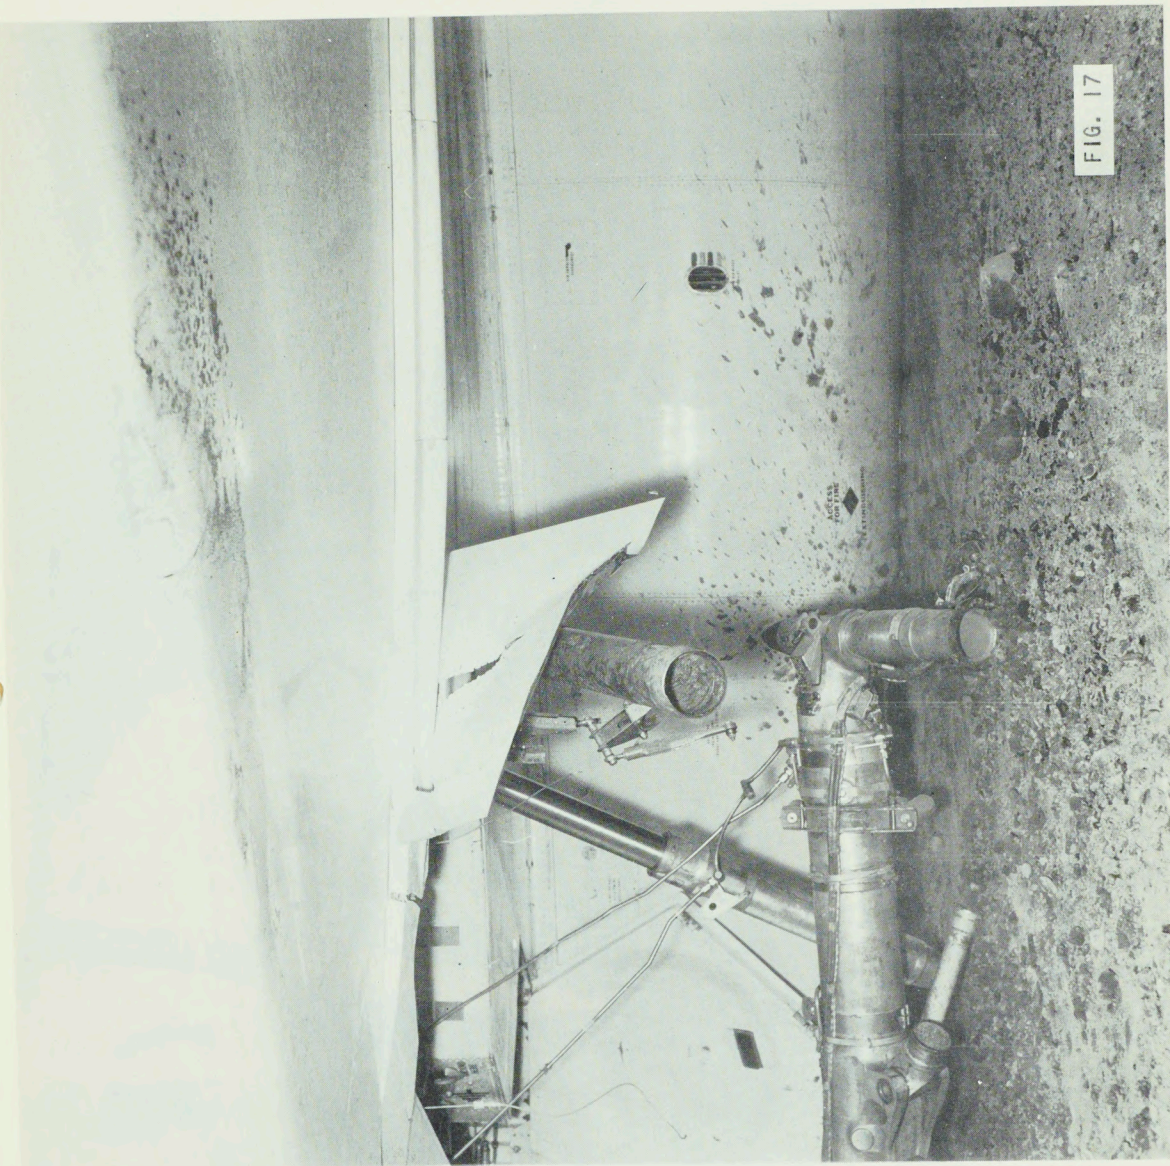
FIG. 17

Photographs taken of the left-hand landing gear shortly after the accident are shown in Figures 17, 18 and 19. Figure 17 shows the retracting chain broken off, and protruding from the dust cover.

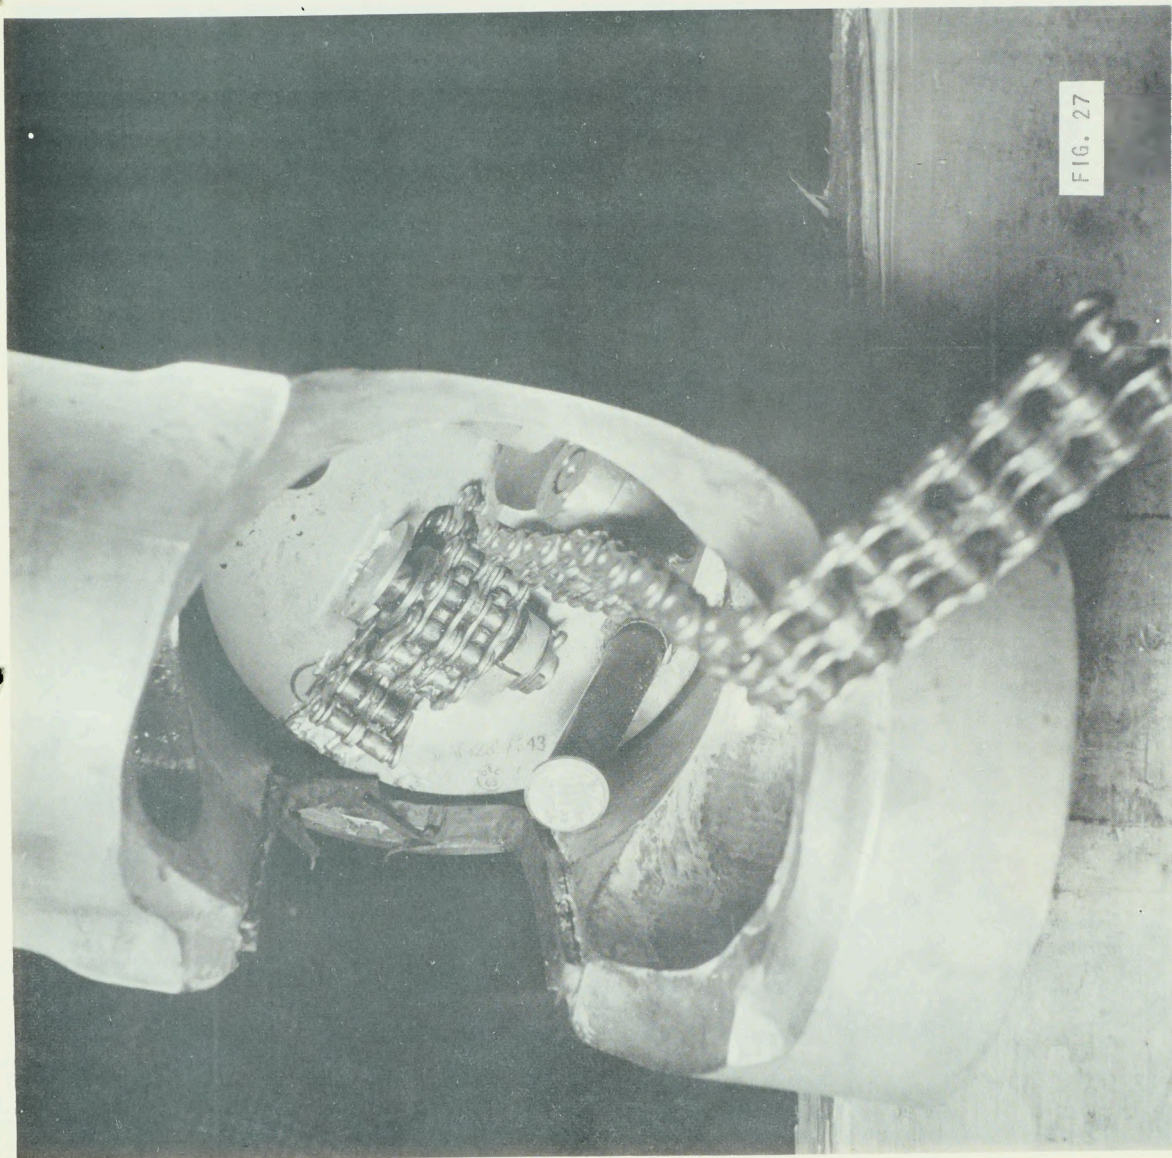
Figure 27 shows the end of the leg with the dust cover removed, revealing the chain and idler sprocket. In addition, this photograph shows that a section of chain is jammed between the sprocket and the end cap, and the sprocket mounting lugs have also failed. However, the jammed chain could also have been caused by secondary damage due to the extension mechanism being pushed two inches past the fully retracted position.

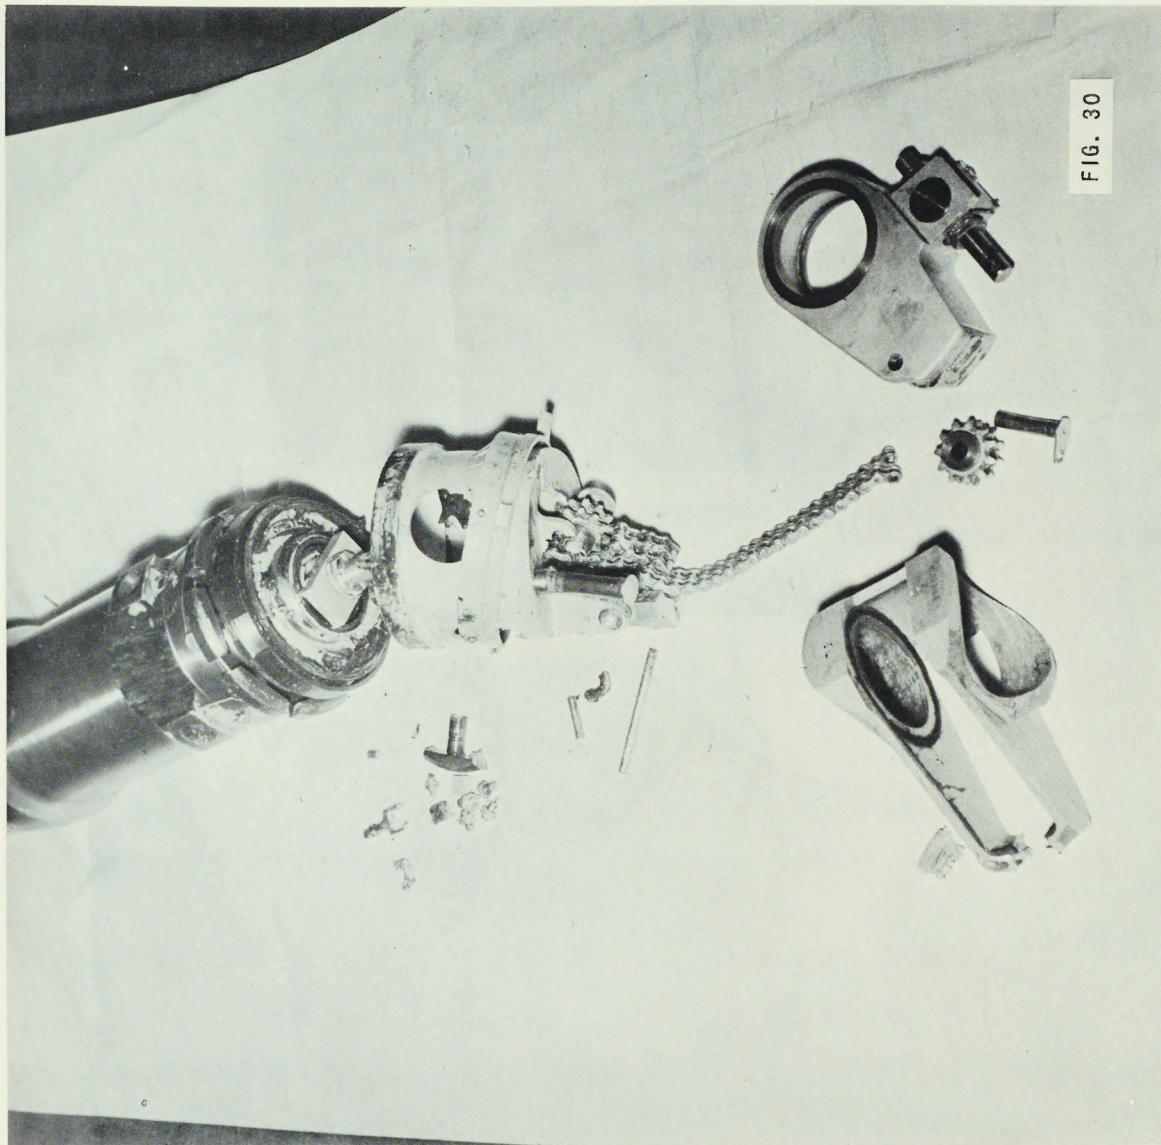
FIG. 30

Figure 30 shows the dust cover, chain and top of the extending gear after they had been withdrawn from the leg forging. Figure 30 shows the fixed portion of the dust cover along with a part of the forging which was torn out by the chain being looped between its moveable piece at the left top corner. Figure 31 shows the chain marks on the dust cover. Figure 32 is a close-up photograph of the fixed part of the dust cover showing part of the forging broken out at the extreme right-hand side. Figure 33 shows the piece of chain which had been broken off and damaged the dust cover. It should be noted that the chain breakage could have been caused when the landing gear was sheared in the final stages of the accident.

Tests were conducted at Dowty on a rig in which the friction at the extension bearing was increased. The locking band bolts were torqued to 410 lbs. ins. instead of 50 lbs. ins. The gear was then lowered, and it was found that the retraction chain looped and jammed in the dust cover, as it closed; the length of chain jamming being about 5 links. The tests were stopped before the gear was fully down in order to prevent damage to the gear. However, on one occasion, when it was thought that the chain was clear, the gear was let go and damage was caused to the dust cover similar to that shown in Figure 30.

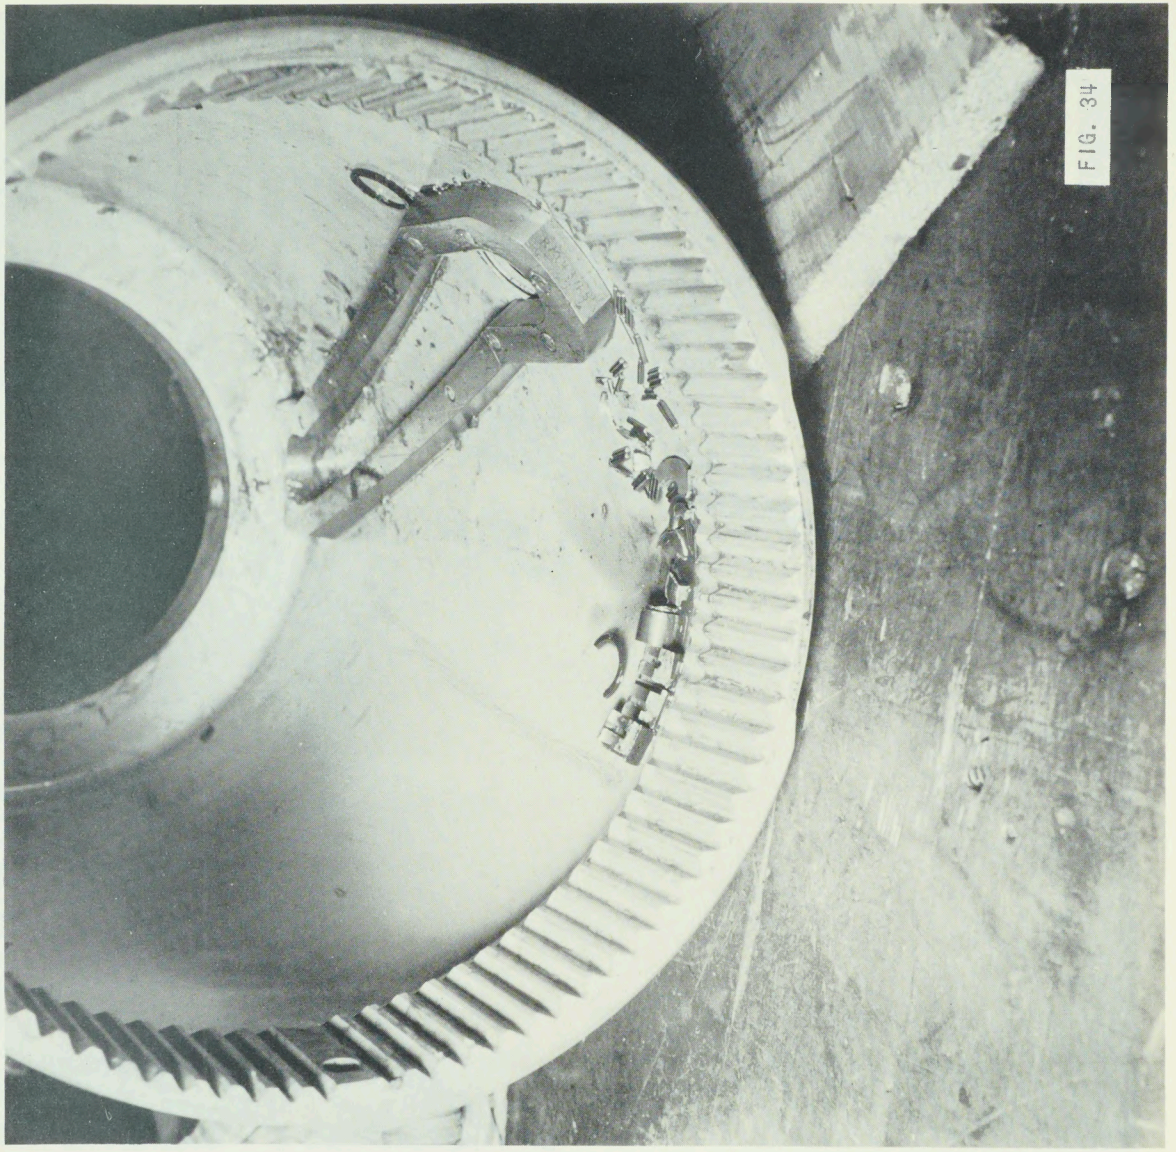
FIG. 34

Figure 34 shows one of the two cam tracks; the rollers in the bottom are broken. This is secondary damage, due to the extending portion of the leg being driven beyond the fully retracted position.

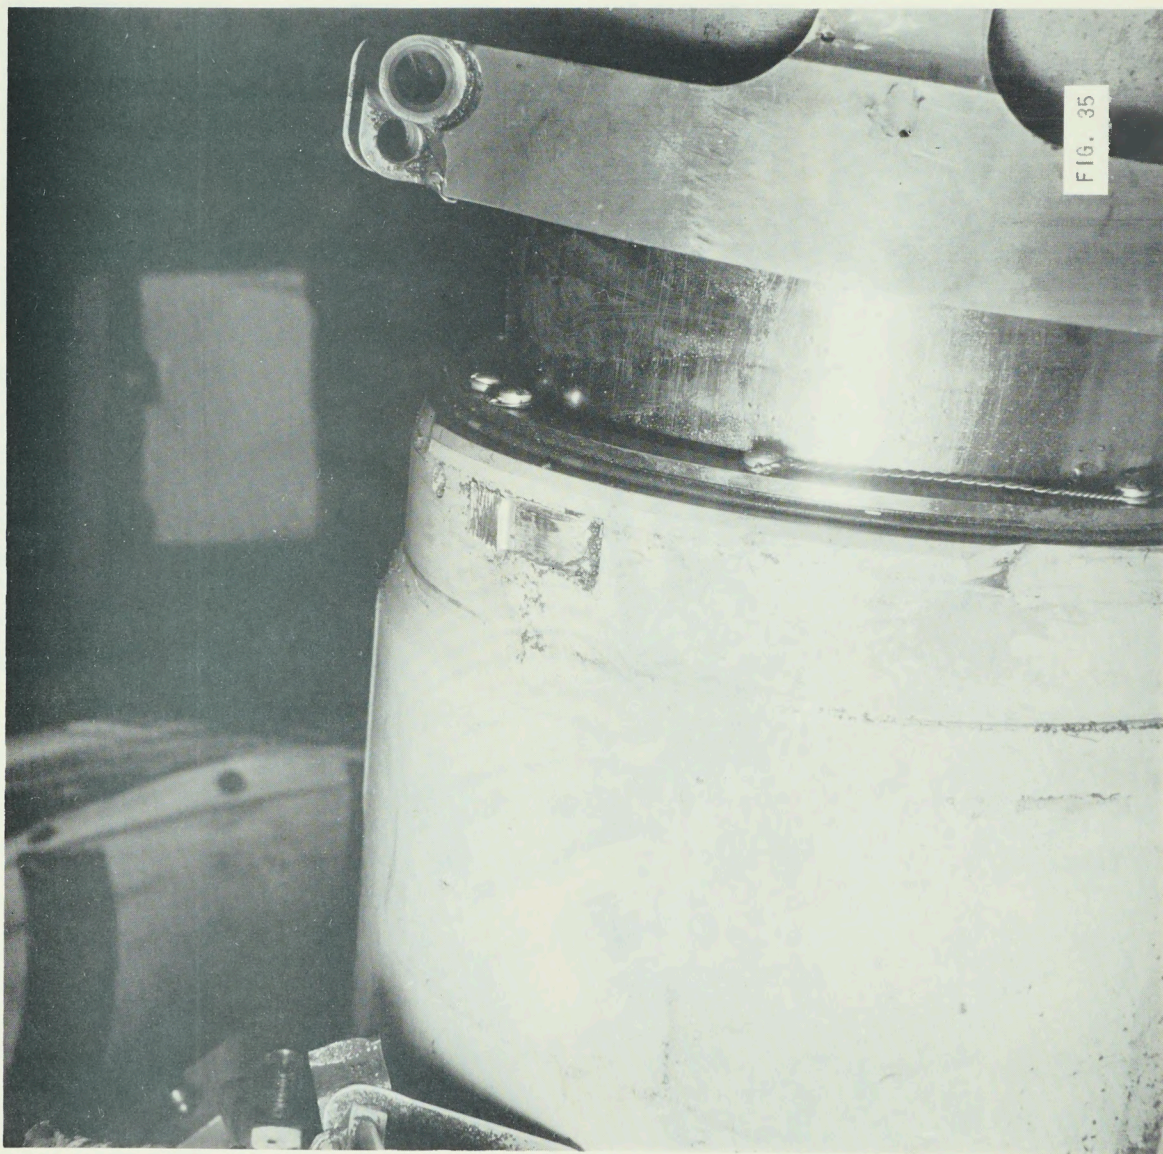
FIG. 35

Figure 35 shows the bearing retaining clamp and the barrel. The marks on the barrel indicate that the band had rotated, and the dowel had scored the barrel. The torque to release the bolts was in the order of 350 lb. in. However, some of this high loading could be attributed to twisting during the final breakage of the leg.

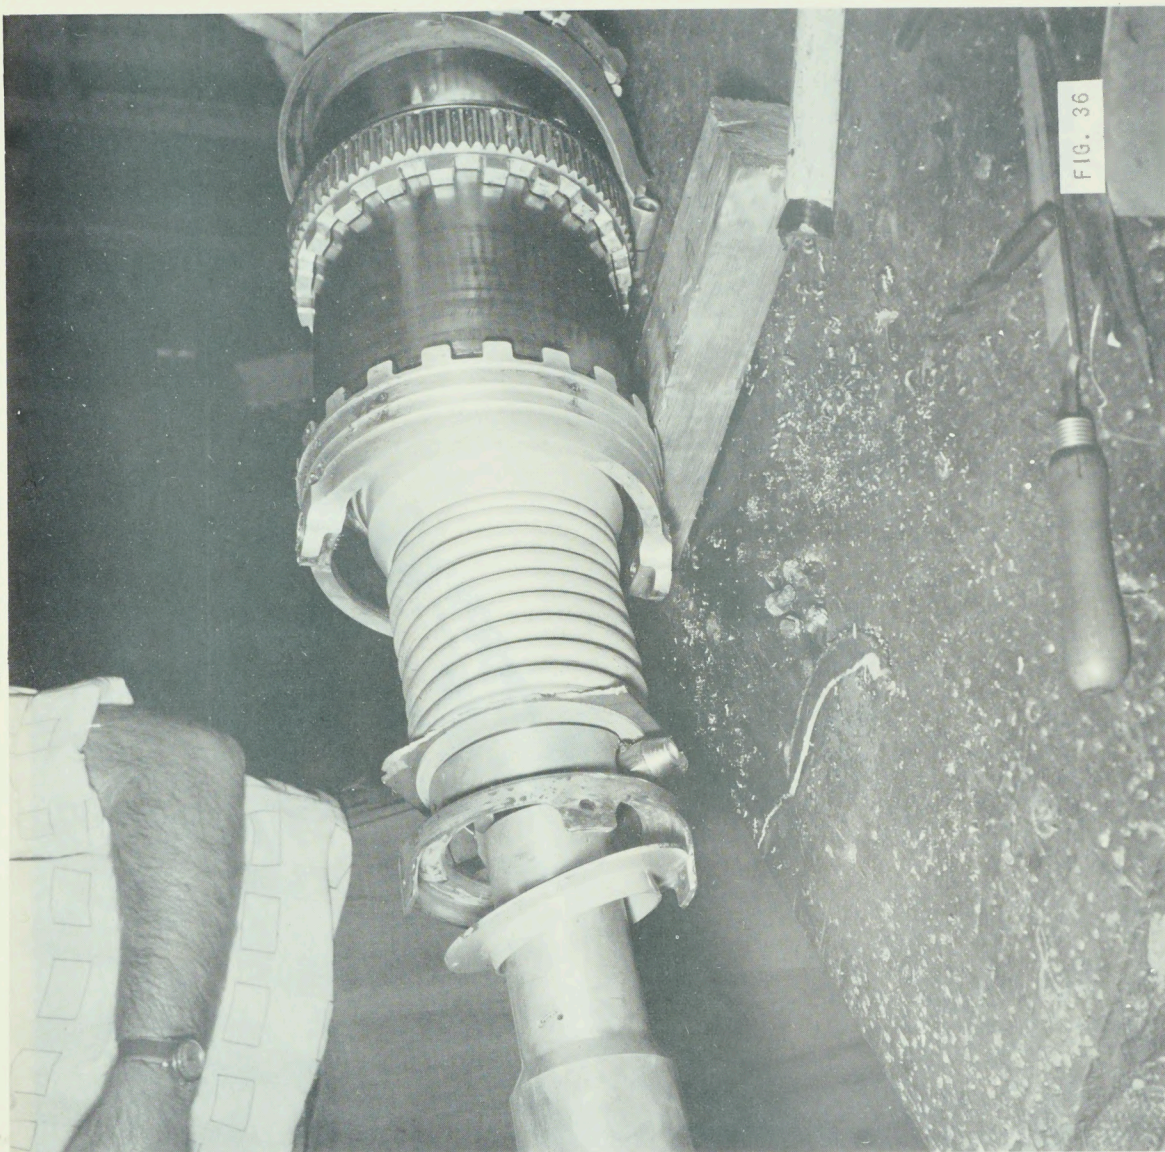
Figure 36 shows the shortening mechanism extension spring, which is almost coil bound. This is due to the locks passing beyond the normal retracted position, forcing off the end cap and then forcing the locking segments out at the top of the cylinder. A metallurgical check on the spring showed that it was according to specification, although it had a permanent set of about 1-1/2 in.

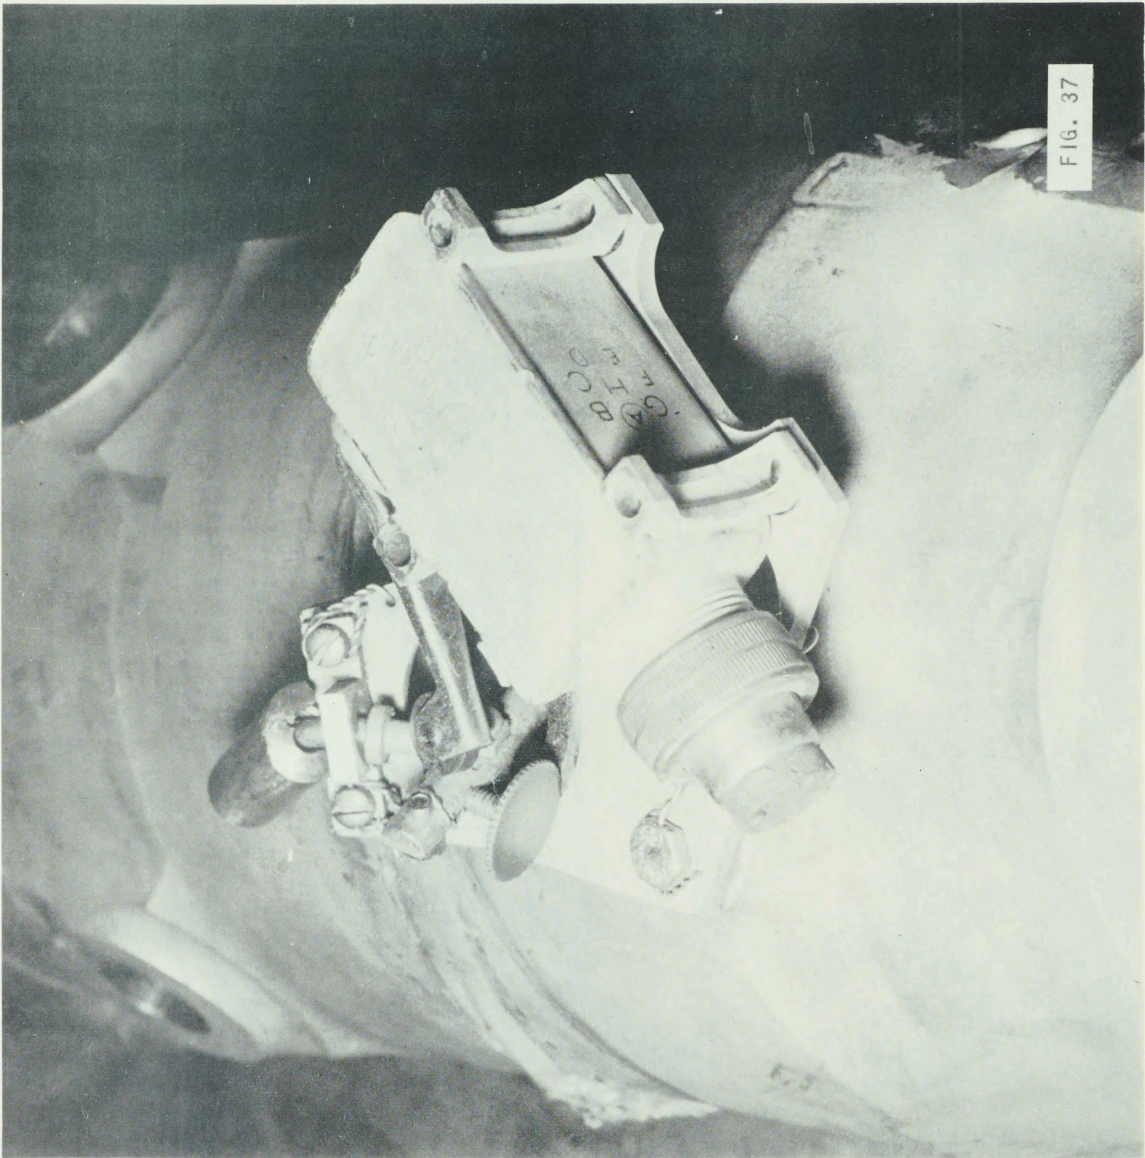
FIG. 37

Figure 37 shows the left-hand landing gear extension micro-switch and Figure 38 shows the left-hand tires.

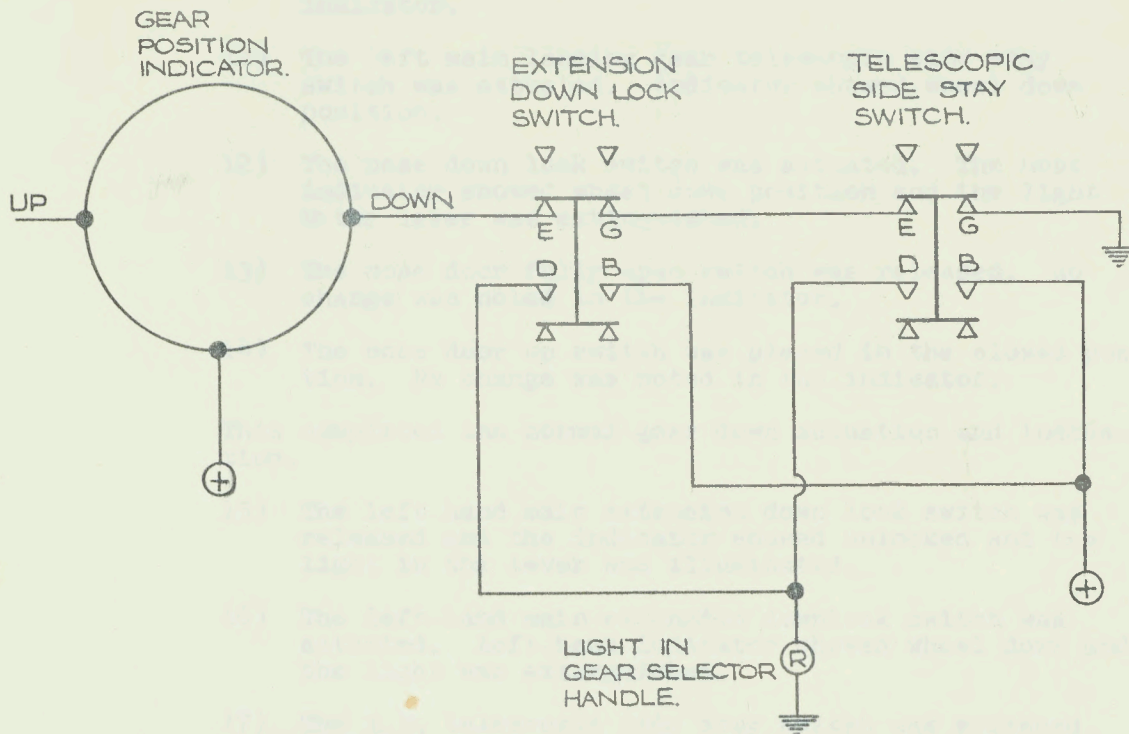
FIG. 39

Figure 39 shows the schematics of the cockpit indicator for the main landing gear. It will be noted that both micro-switches must be actuated in order to indicate GEAR DOWN - LOCKED. The working drawings were checked to ensure that the system had been correctly converted into the aircraft wiring drawings. The drawings were found to be correct. The harness from the left-hand landing gear was then re-fitted to the aircraft and circuit checks were made. The side stay micro-switch was found to be un-serviceable, and a new switch was installed for the check. It is considered that the failure of this switch was due to the secondary damage, since the pilot's indicator showed the gear to be locked down. This indication would be given if both side stay and extension micro-switches are actuated and serviceable. (Ref. Figure 39.)

The above tests proved that the aircraft wiring was correct and the false indication must have been caused by micro-switch maladjustment or jamming in the wheels down position. If this switch was permanently in the actuated condition, the indication would be in order i.e. "wheels down" when the side stay was actuated and "wheels up" when the gear was retracted and the side stay micro-switch released.

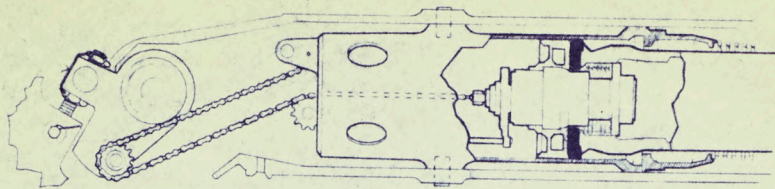
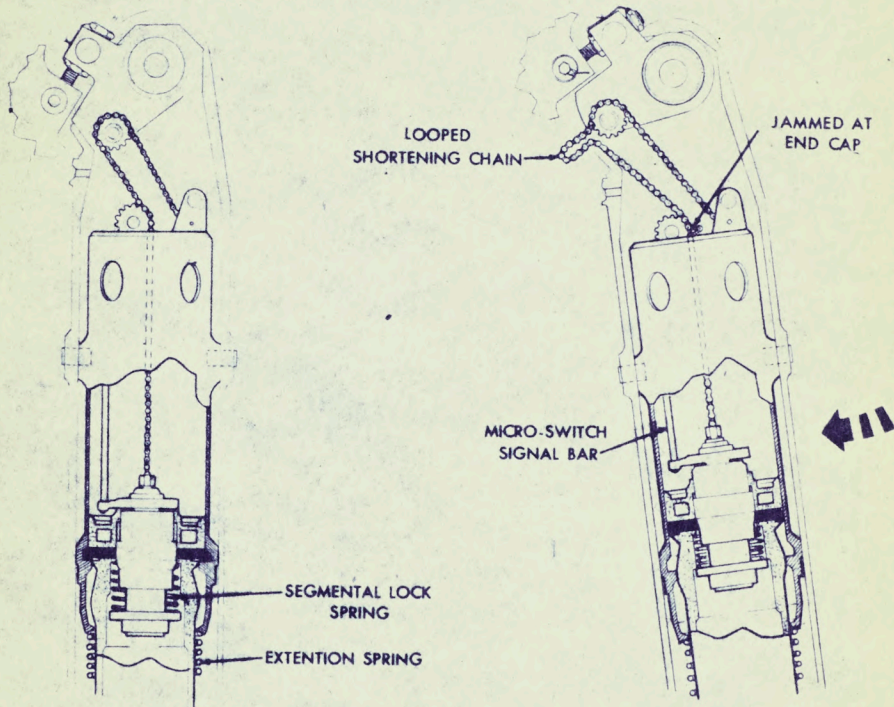
FIG. 44 DETAIL OF LEG SHORTENING MECHANISM

The main landing gear failed to extend properly. The first malfunction occurred when a "hang up" kept the extension mechanism from lowering, causing an excess amount of chain at the upper end of the gear. (See Fig. 44.)

This "hang up" cleared itself during extension, but the excess amount of chain had jammed, making proper extension impossible. Detail design of the chain mechanism is such as to make jamming almost certain if there is excess chain.
