~~RESTRICTED~~  
**UNCLASSIFIED**  
REPORT OF ACCIDENT TO  
AVRO AFGW 1 25201  
AT WILTON  
**UNCLASSIFIED**

REPORT ON ACCIDENT

AVRO ARROW I 25201

June 11, 1958

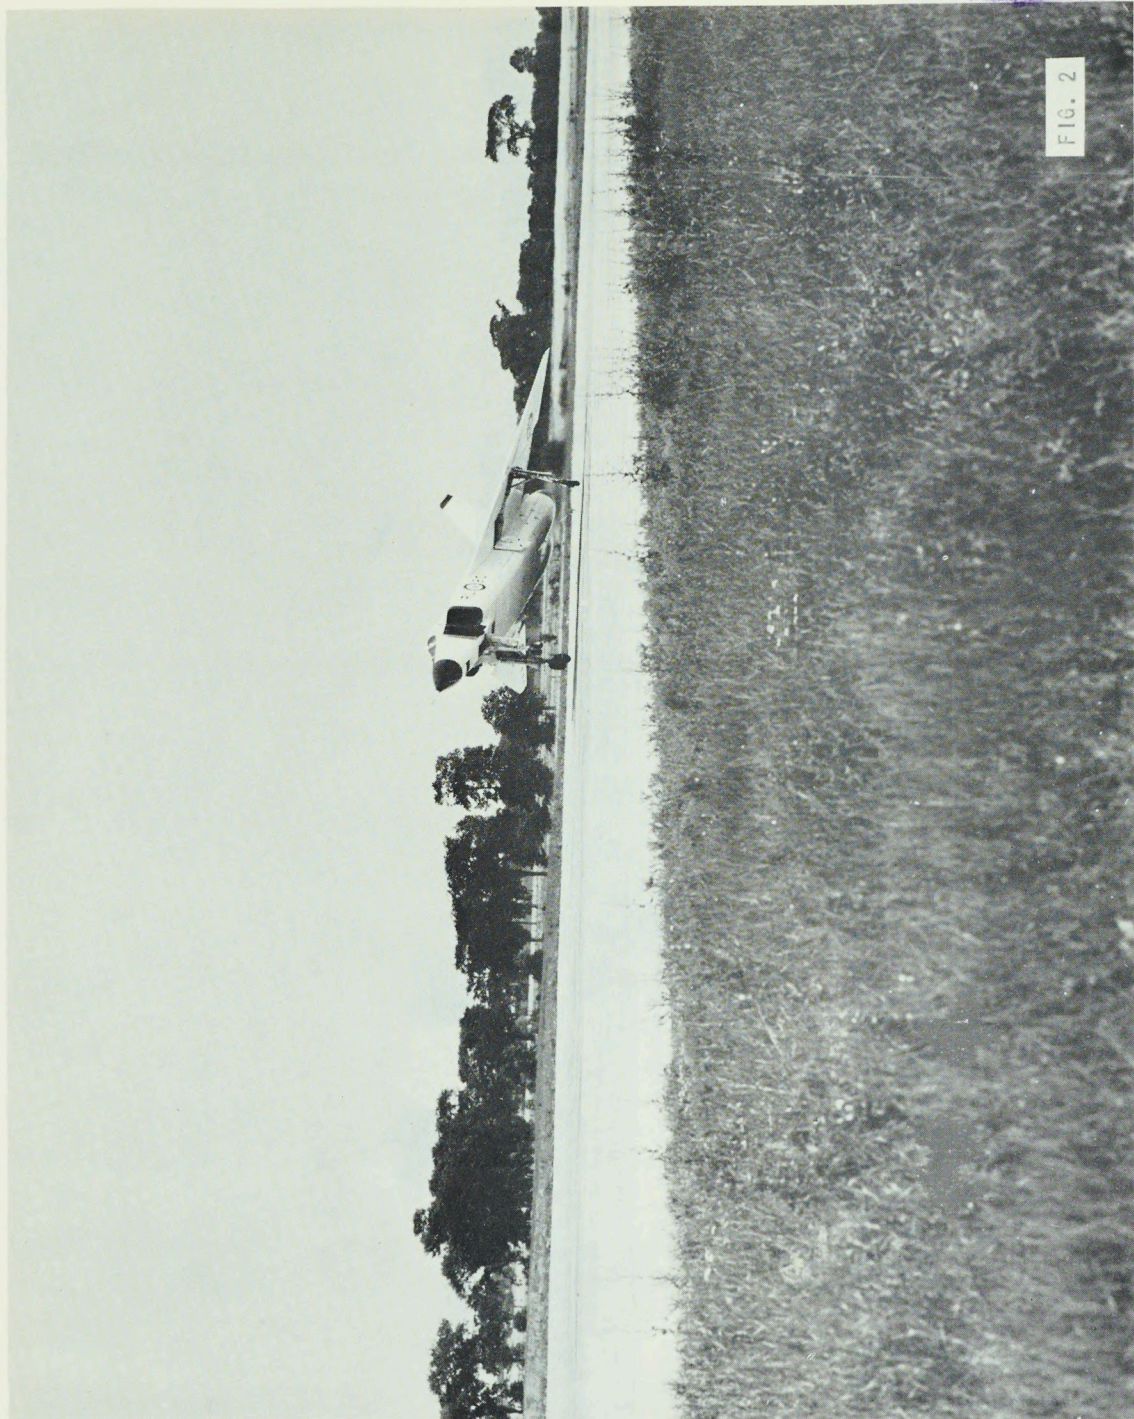
FIG. 2

The pilot selected landing gear when in the circuit for landing and as stated in section 3.2, the cockpit indicators showed DOWN and LOCKED. The aircraft touched down on the end of runway 32. (Ref. Fig. 1.) Figure 2 shows that the L.H. leg extension and turning had not been completed prior to touchdown. The partial extension can be seen and that the wheels were not in line with the aircraft's longitudinal axis.

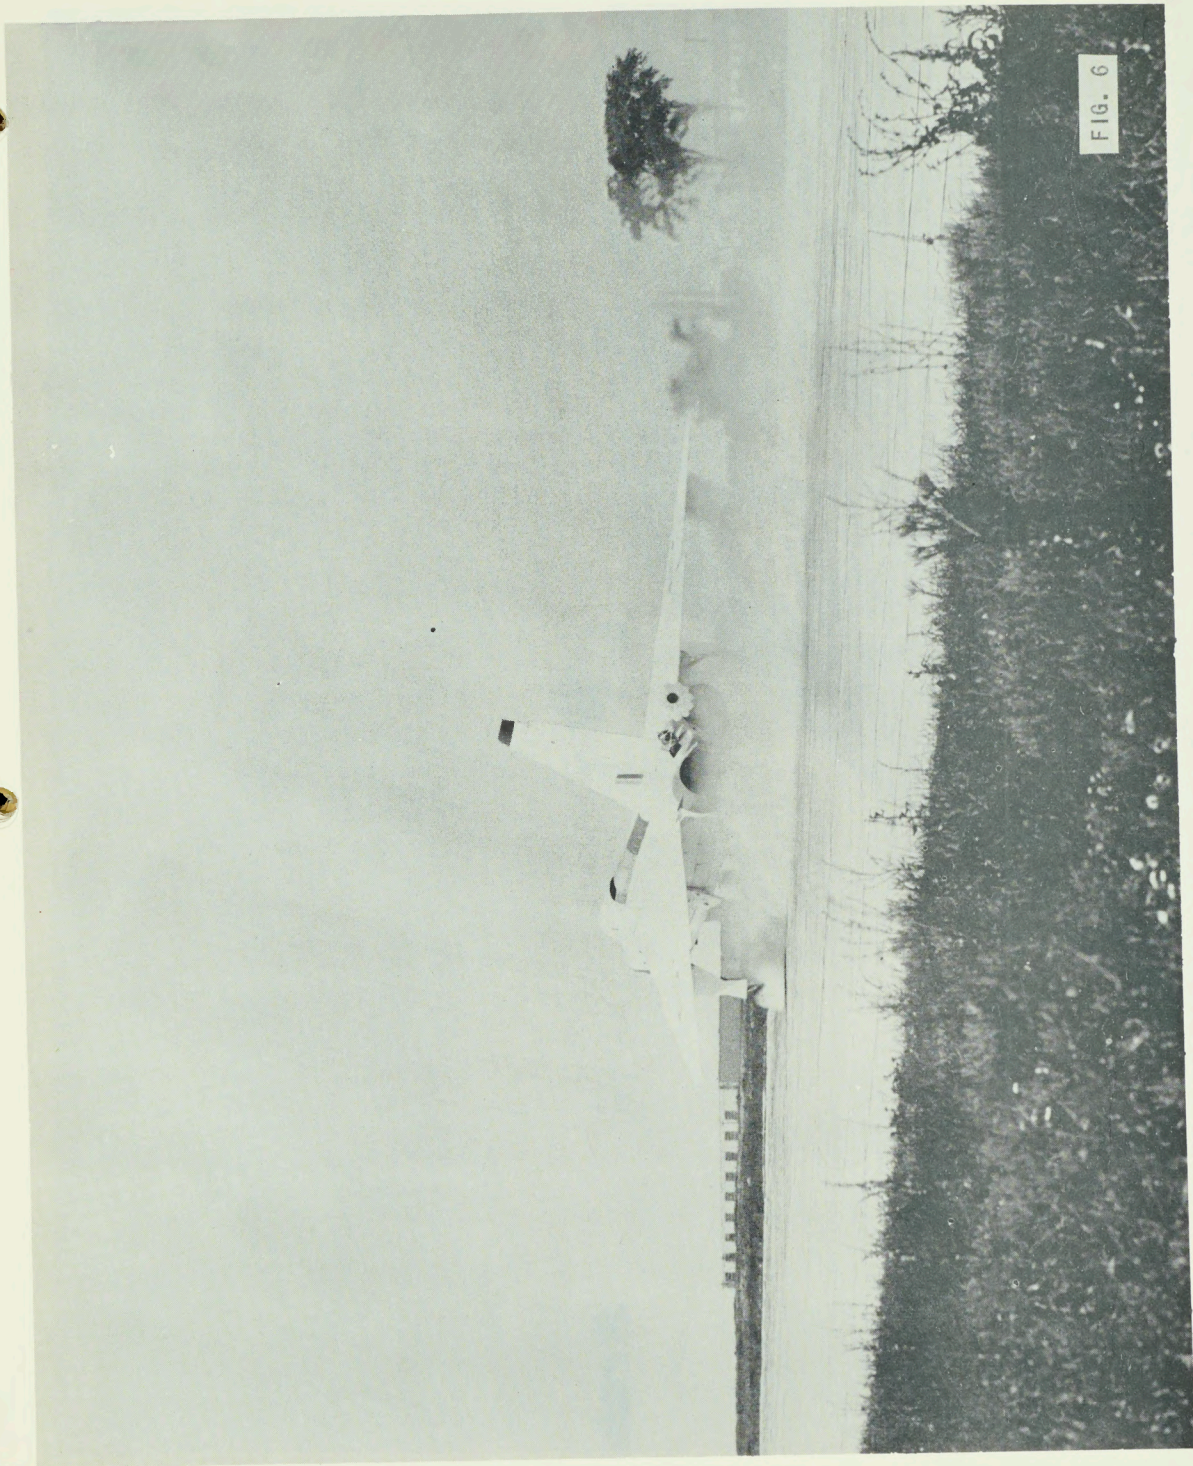
FIG. 6

Immediately after touch down (Fig. 3), the aircraft's weight caused the left-hand landing gear to turn further and assume the position which it would normally occupy when stowed in the landing gear bay (Ref. para. 3.3). The drag chute was then deployed. Figure 6 shows smoke coming from the left-hand tires, due to their misalignment with the aircraft's path. The aircraft continued to swing towards the left-hand side and corrective brake action had no effect in arresting the swing. The pilot then considered that the drag chute may be causing the swing and jettisoned the chute. Figure 7 shows the aircraft in various positions until it left the runway. When the left-hand wheel struck the soft ground, the aircraft swung violently to the left, causing the landing gear to collapse due to the excessive loads imposed on it. Figures 12 and 13 are aerial photographs taken shortly after the accident. The skid marks shown on Figure 14 are those made by the left-hand landing gear at the touchdown point, and indicates the increase in the spread of the tires, as the bogie is twisted further out of line, due to the increasing weight on the landing gear. Figure 15 indicates the point at which the left-hand tires burst. This occurred at approximately 3/5 of the total distance which the aircraft travelled (approximately 4,000 ft.).

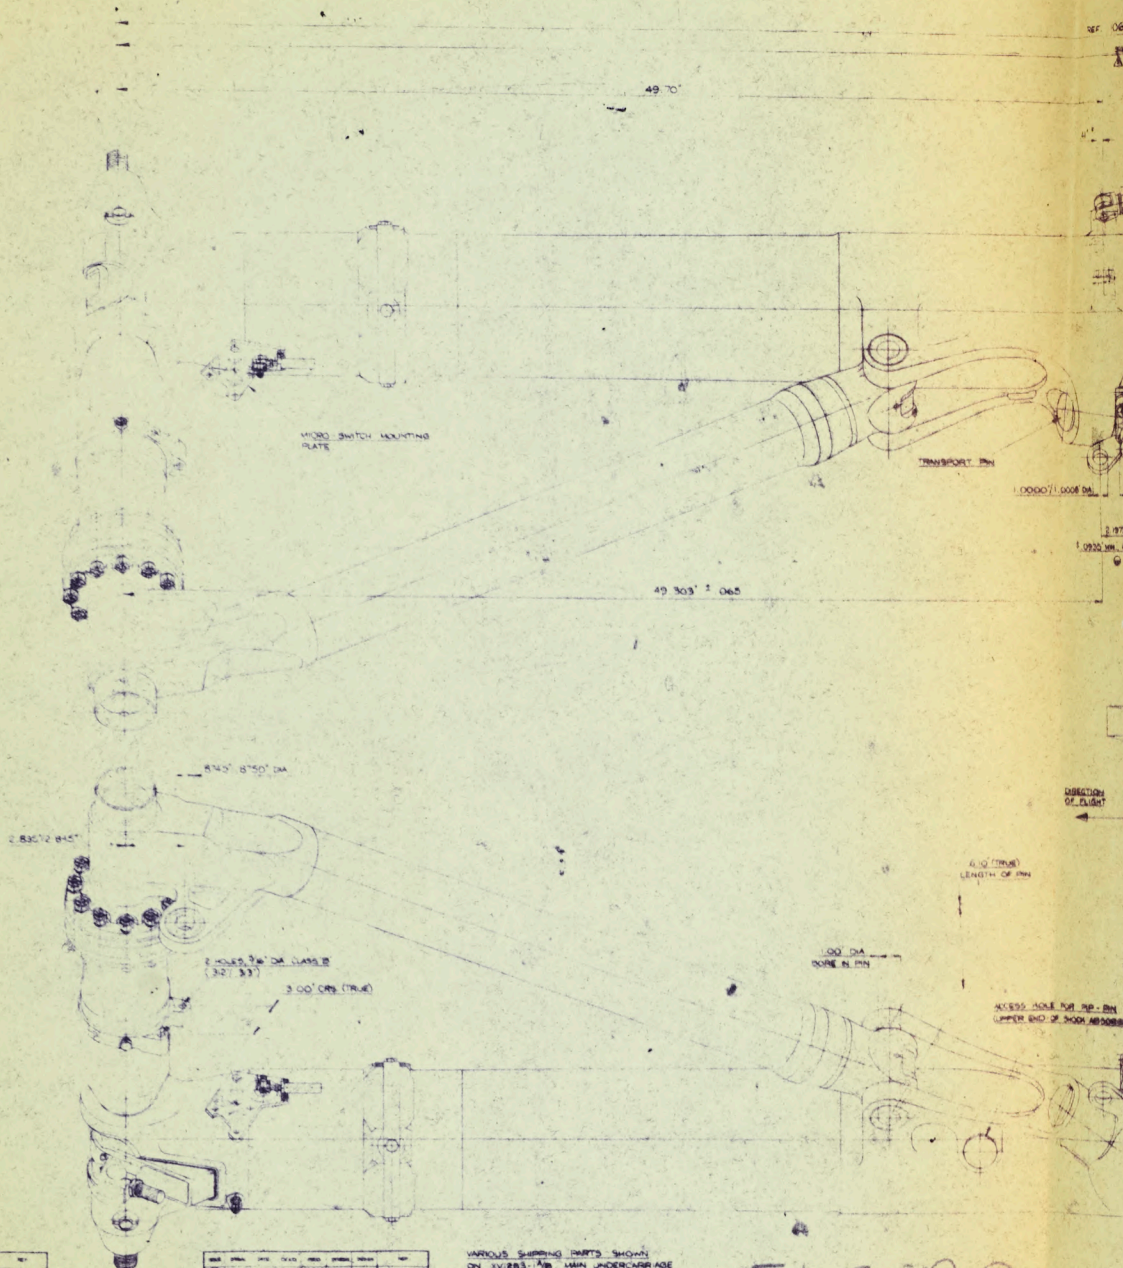
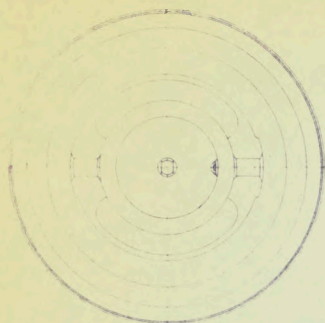
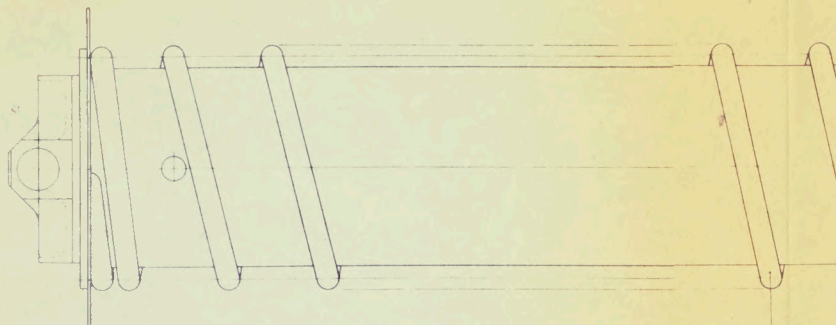
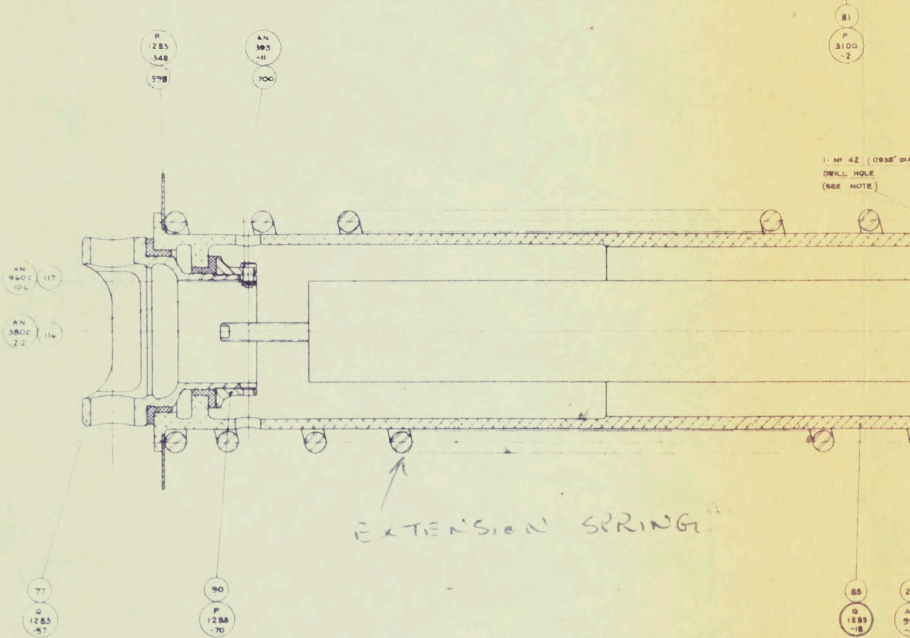
FIG. 20

The landing gear consists of a main leg which is braced by a rear drag strut and a telescopic down lock strut (Ref. Figure 20). In order to permit adequate fuselage ground clearance on landing, the length of the main landing gear is such that in its fully extended position the leg would not fit in the wheel well, on retraction. A mechanism has therefore been incorporated in the main leg, which during retraction, draws the shock absorber into the main landing gear strut, thus reducing the leg length approximately 8 inches. At the same time the wheel bogie is turned through approximately 40° so that the wheels will lie flush with the wing contour when retracted, since the wings are set at 4-1/2° incidence to the static ground line. During the extension cycle the landing gear is lengthened and the bogie rotated so that the wheels will be parallel with the aircraft's longitudinal axis.

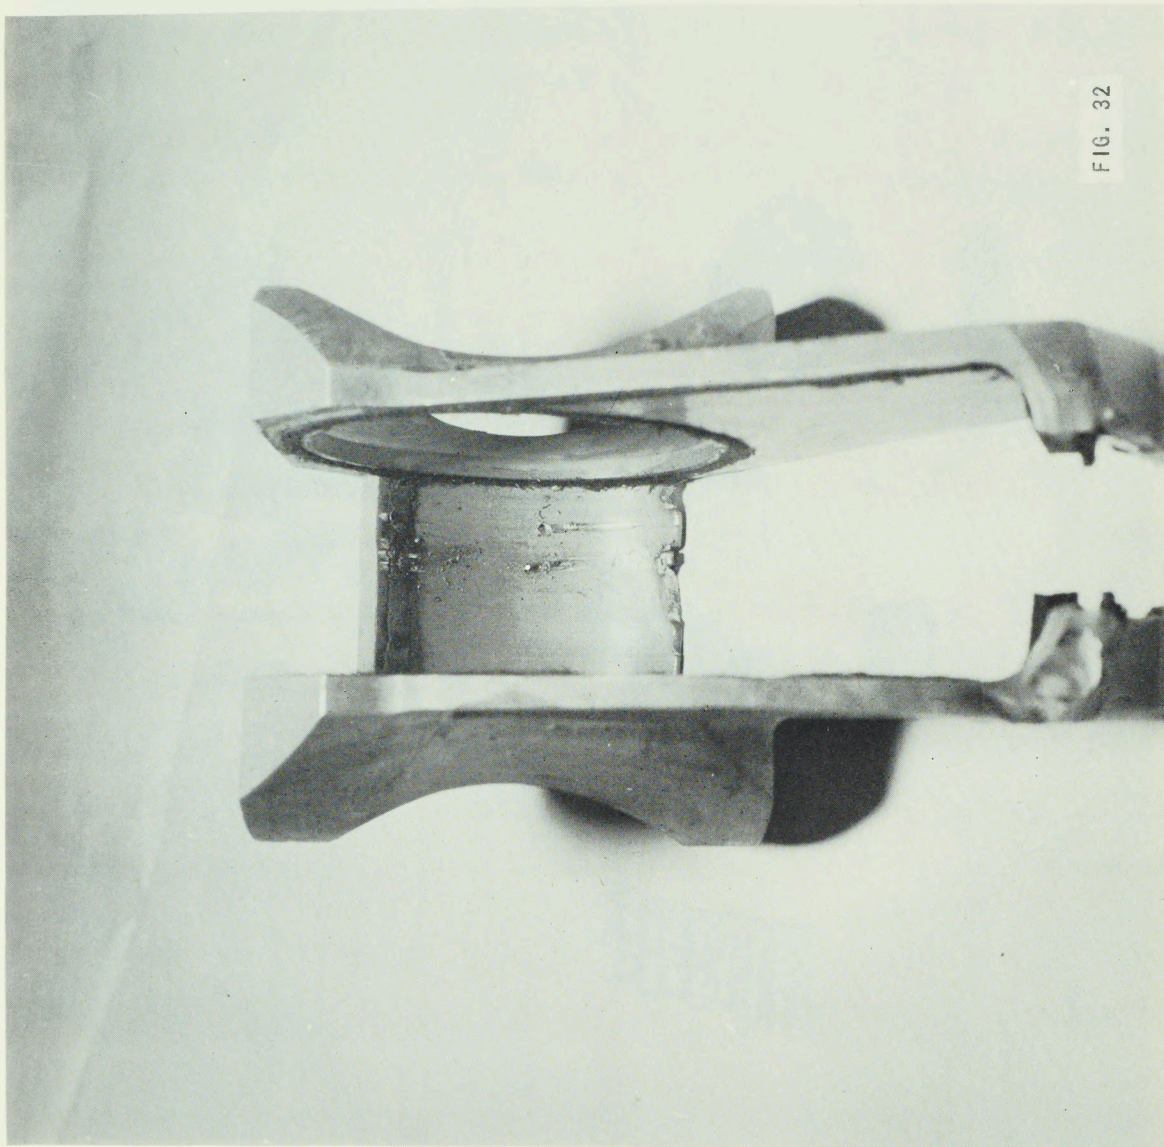
FIG. 32

Figure 30 shows the dust cover, chain and top of the extending gear after they had been withdrawn from the leg forging. Figure 30 shows the fixed portion of the dust cover along with a part of the forging which was torn out by the chain being looped between its moveable piece at the left top corner. Figure 31 shows the chain marks on the dust cover. Figure 32 is a close-up photograph of the fixed part of the dust cover showing part of the forging broken out at the extreme right-hand side. Figure 33 shows the piece of chain which had been broken off and damaged the dust cover. It should be noted that the chain breakage could have been caused when the landing gear was sheared in the final stages of the accident.

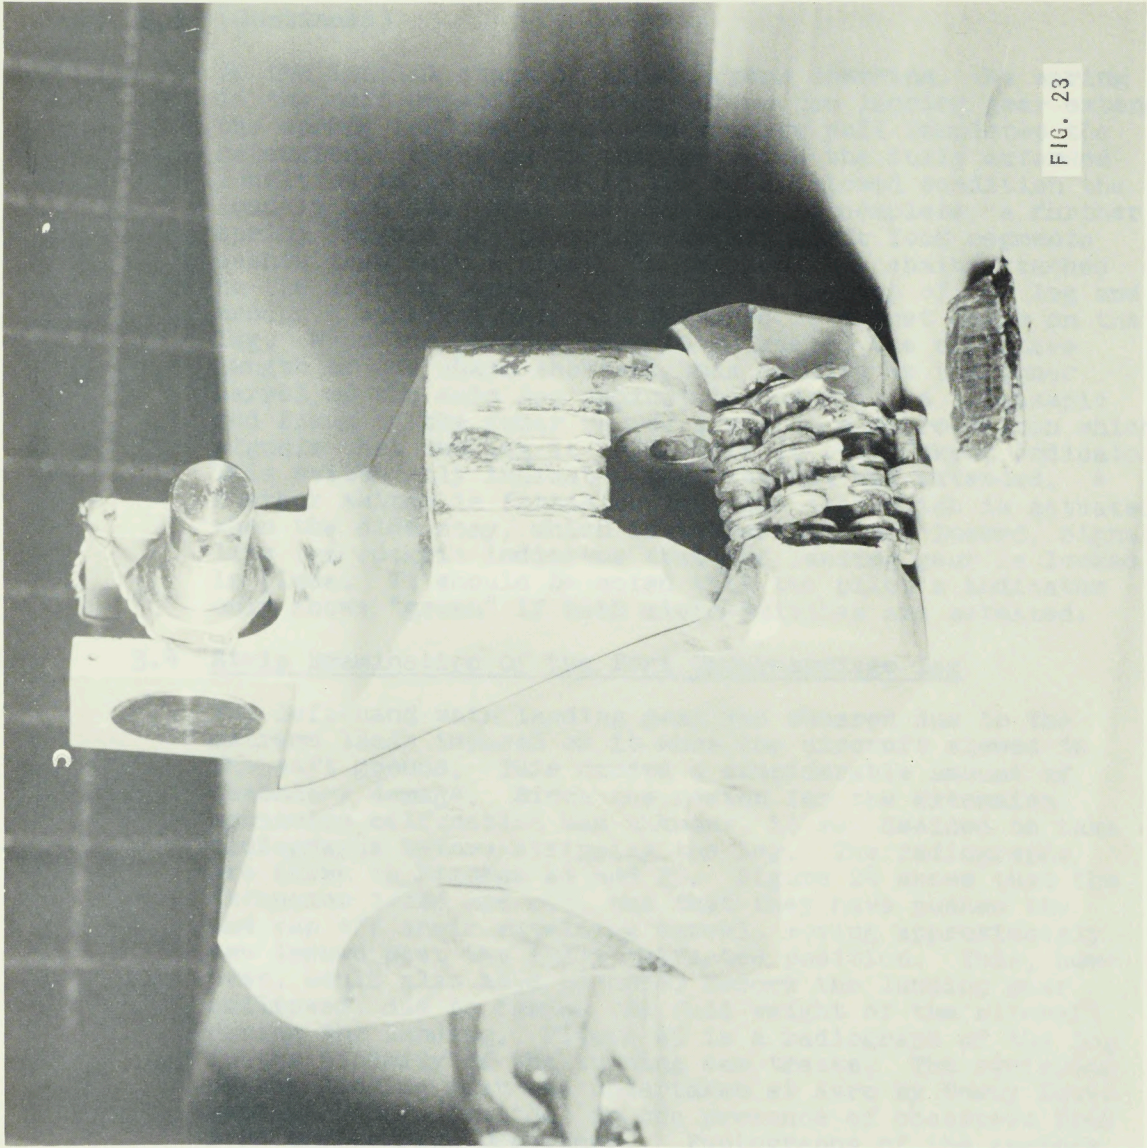
FIG. 23

Turning is accomplished by means of two cam tracks on the main leg barrel and two rollers on the extending unit. The main oleo is attached to the shortening gear, therefore, the oleo is active whether the extension is up or down. Figure 21 shows the main leg details and Figure 22 shows the shortening mechanism details lock. The dust cover is shown on Figure 23.
